**SwRI AIRBAG DEPLOYMENT INVESTIGATION  
FULL SCOPE**

**CASE NO. 9002AB**

**FINAL REPORT**

SwRI Project 06-1977  
DTNH 22-87-C-37169

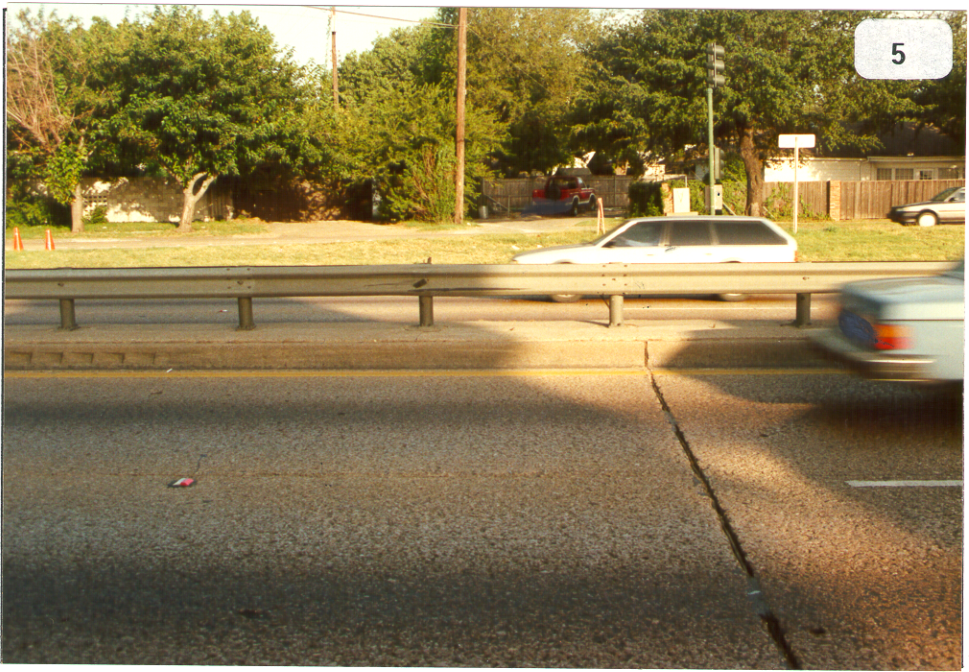
<b><u>Photo No.</u></b>	<b><u>Description of Subject Matter</u></b>
1.	Scene in direction of vehicle travel
2.	Scene in direction of vehicle travel
3.	Scene in direction of vehicle travel
4.	Scene against direction of vehicle travel
5.	Impact area on median barrier
6.	Exterior damage to airbag vehicle
7.	Exterior damage to airbag vehicle
8.	Exterior damage to airbag vehicle
9.	Exterior damage to airbag vehicle
10.	Interior of airbag vehicle
11.	Interior of airbag vehicle
12.	Interior of airbag vehicle
13.	Module cover bottom
14.	Module cover top
15.	Steering wheel rim
16.	Airbag. Note that the bag had been stuffed into module after deployment
17.	Airbag
18.	Airbag
19.	Interior of airbag vehicle

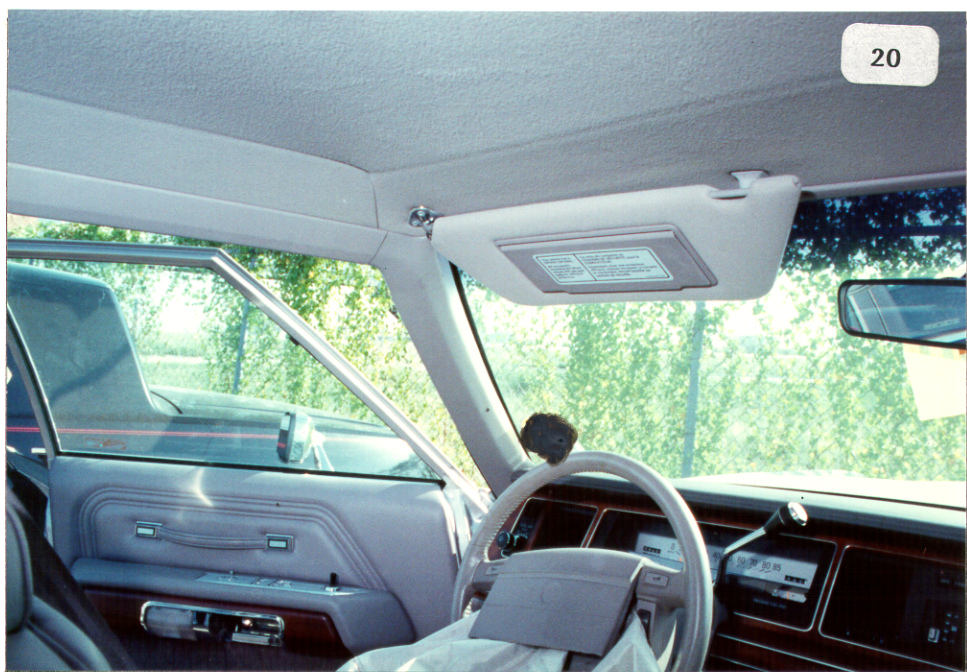
21

<b>Photo No.</b>	<b><u>Description of Subject Matter</u></b>
20.	Interior of airbag vehicle
21.	Interior of airbag vehicle
22.	Interior of airbag vehicle
23.	Interior of airbag vehicle
24.	Note loading ripples in belt webbing
25.	Intrusion in rear seat
26.	Exterior of vehicle 2
27.	Exterior of vehicle 2
28.	Exterior of vehicle 2
29.	Exterior of vehicle 2
30.	Exterior of vehicle 2
31.	Exterior of vehicle 2
32.	Exterior of vehicle 2
33.	Exterior of vehicle 2
34.	Exterior of vehicle 2
35.	Interior of vehicle 2
